Klamath National Forest Best Management Practices

REGION 5 EVALUATION PROGRAM WATER QUALITY MONITORING REPORT 2009 Fiscal Year

December 22, 2009

Prepared for Klamath National Forest by Vegetation Management Solutions Enterprise Team

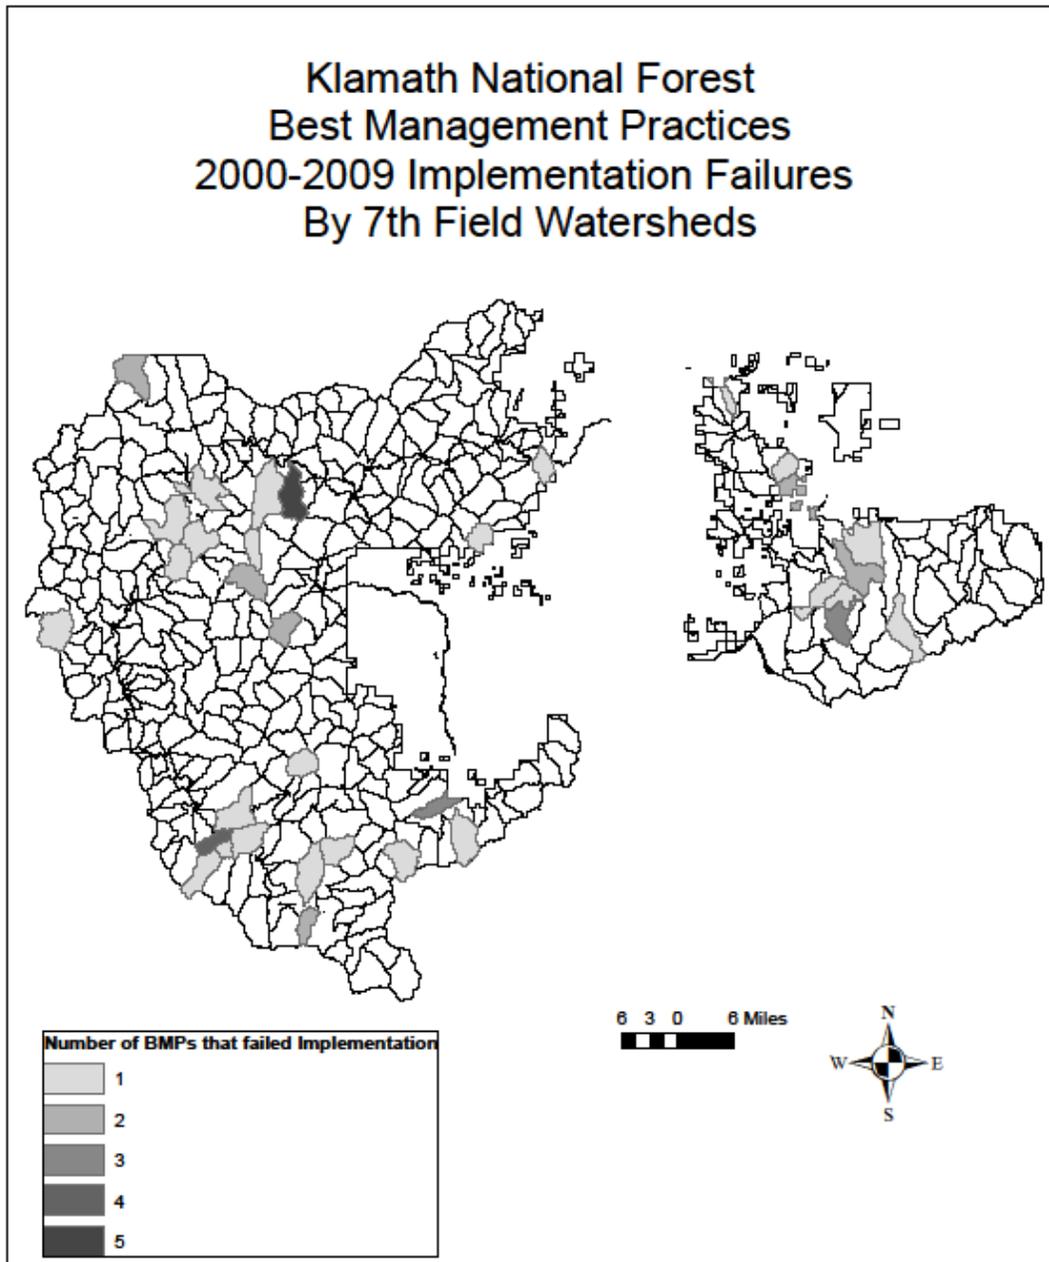
Figure 1. Impementation failures of all evaluations by 7th field watersheds

Figures 1 and 2 present BMP evaluation data by 7th field watershed. There is a need to integrate the BMP monitoring process with other, watershed based, monitoring programs on the Klamath National Forest. Analyzing BMP evaluation by watershed allows this type of monitoring to be correlated to in-stream monitoring. Through this process, we can better establish cause and effect relationships between activities on the hillslope and impacts to the stream channel. In Figure 1, the implementation failures for all BMP evaluations from 2000 to 2009 are presented by 7th field watershed. Walker Creek had the most failures with five, followed by McNeal-Glasgow with four. Blue Canyon and Wildcat Creek both had three failures. Thirty other watersheds had either one or two BMP implementation failures.

attention should be paid to these watersheds to monitor possible effects of BMP implementation or effectiveness failures to in-stream water quality indicators.

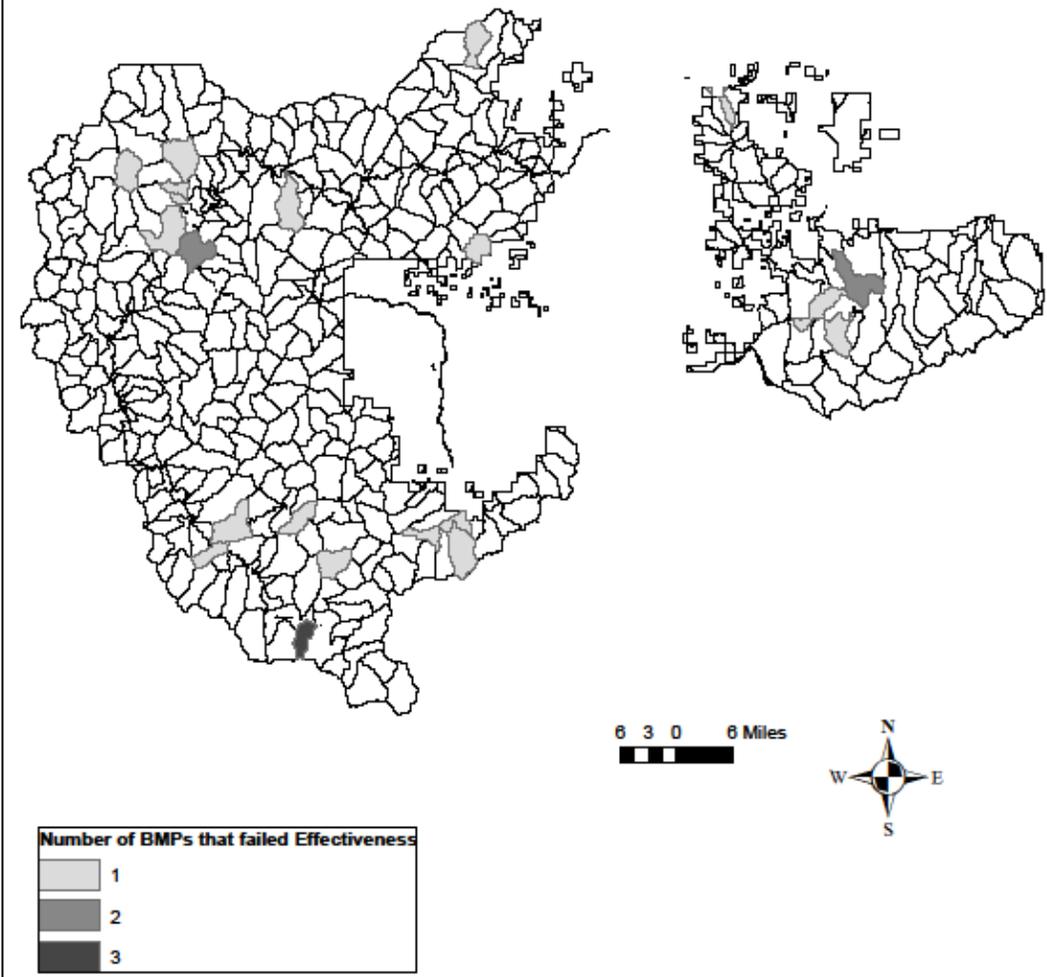
Figure 2. Effectiveness failures of all evaluations by 7th field watersheds

In Figure 2, the effectiveness failures for all BMP evaluations from 2000 to 2009 are presented by 7th watershed. Cecil Creek had the most failures with three, followed by Bray-Butte Creek and Cougar-Malone with two. Sixteen other watersheds had one BMP implementation failure. In the future, special
